MSHA METAL/NONMETAL ELECTRICAL GROUNDING REQUIREMENTS

Presented at the IEEE Cement Industry Technical Conference

May, 1981

William J. Helfrich

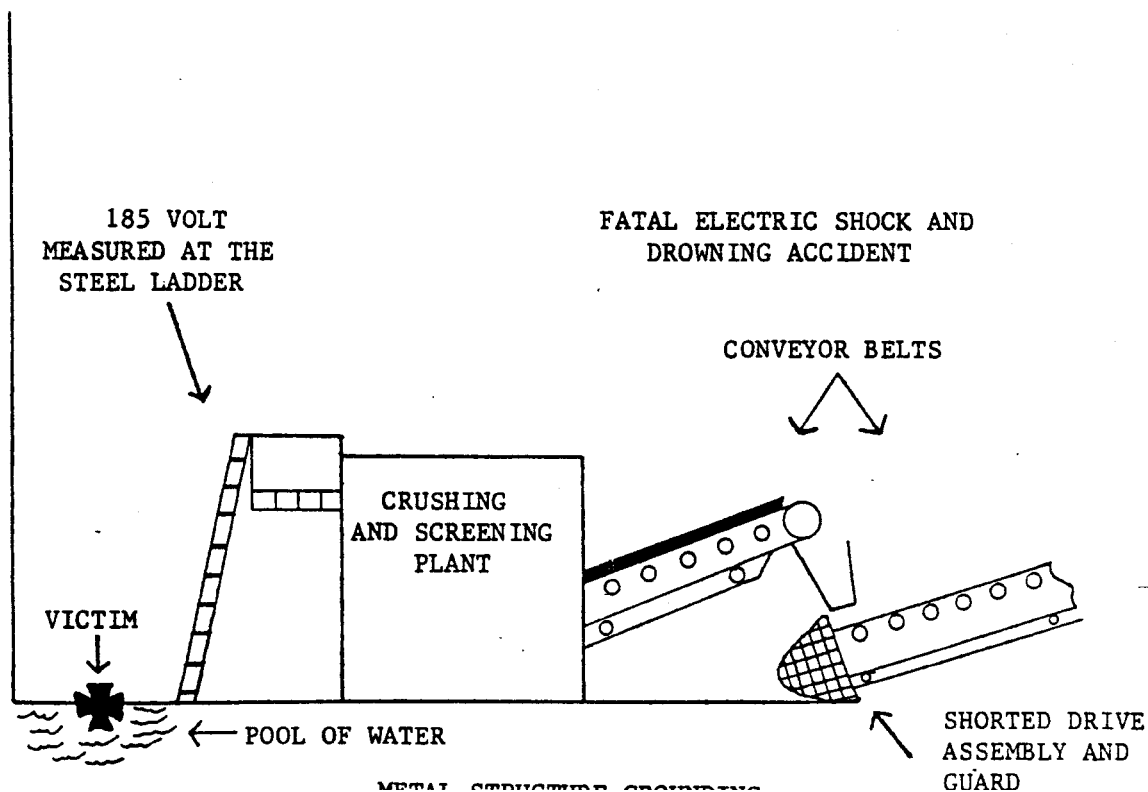
Figure 1. Metal Structure Grounding

The following accident clearly illustrates the importance of grounding the metallic portions of buildings. The operator of a front end loader walked from the end of the crushing and screening plant to the front side and started to climb up the metal ladder on the side of the plant. The plant with the approximate location of the victim are illustrated in Figure 1.

The loader operator received an electrical shock on touching the ladder. A foreman who was near the main power switch disconnected the power from the plant. When the foreman and the plant operator went to look for the loader operator they found him submerged in a pool of water at the base of the ladder.

The investigation revealed that a 1-1/2 hp motor on a conveyor of the crushing plant was short-circuited through a piece of wire mesh which was being used as a chain drive guard. The guard, which was not rigidly fixed, had worn a hole in the insulation of the powerline. The motor was not frame grounded and the resulting short delivered approximately 180 volts to the frame of the crushing and screening plant. The voltage from the guard to ground measured 285 volts. When the guard was removed from the motor, the voltage on the ladder disappeared.

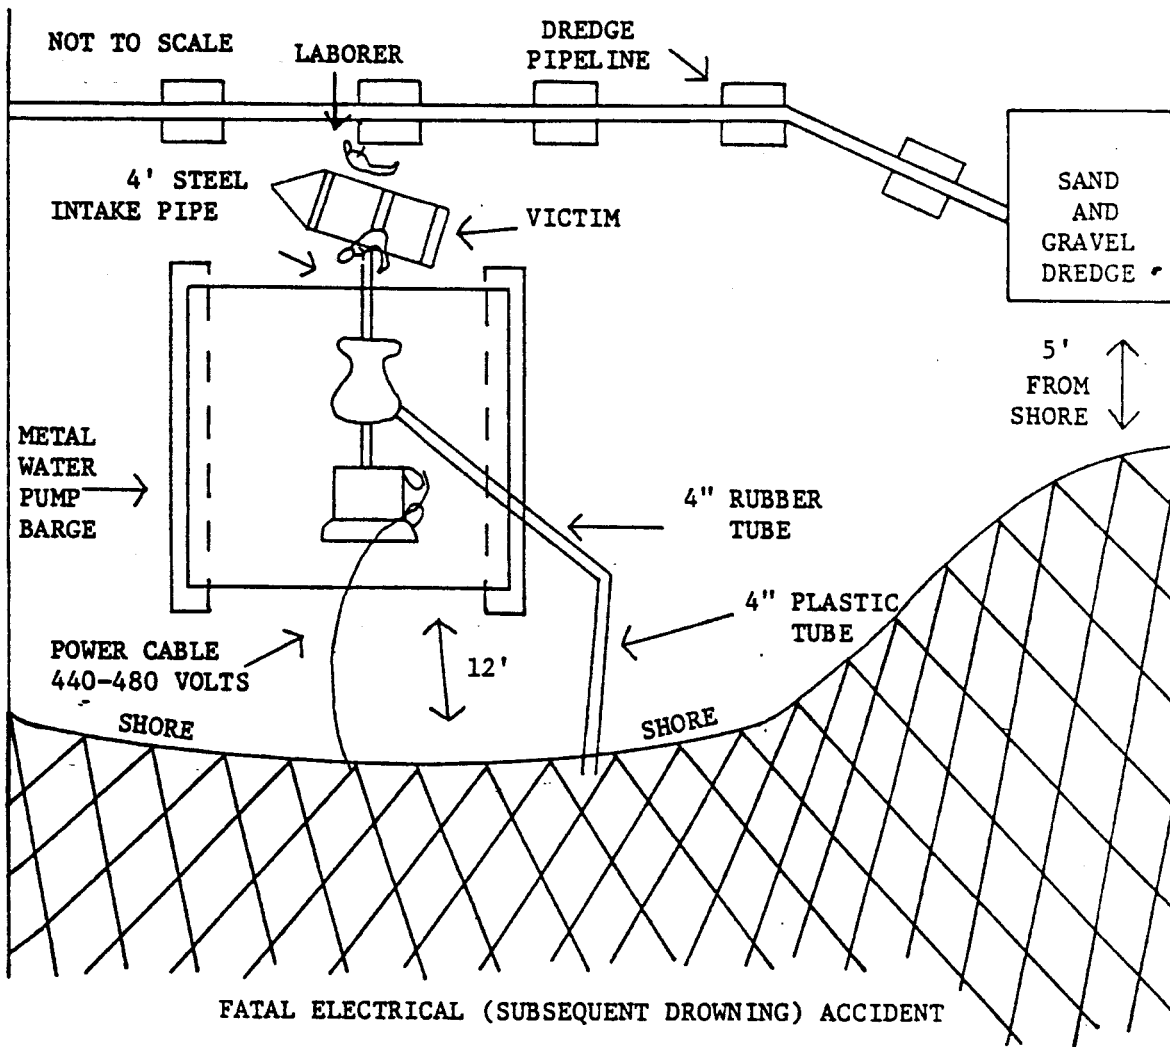
Figure 2.

The pumping unit and approximate locations of the victim are shown in figure 2. The centrifugal pump was powered by a 440 volt motor through a direct drive coupling. An aluminum rowboat was used to gain access to the unit.

Upon reaching the pump barge in the aluminum boat, the victim was in the center of the boat with the laborer in the front of the boat. When the victim put one hand on the 4-inch intake water pump, he received an electric shock. This caused the victim to fall into the water which was 25 feet deep.

The direct cause of the accident was the failure to ground the pump drive motor to the power control panel in the plant. A contributing cause was the failure to properly secure the power cable to the water pump unit: this undoubtedly caused the insulation to wear, thereby exposing the bare wire.

The operator of a sand and gravel operation died as a result of an electric shock and/or drowning. After receiving an electric shock from the intake pipe of a floating water pump unit, the operator fell into approximately 25 feet of water. The floating water pump unit where the accident occurred had been recently installed. During the installation of the unit, it was found that the 4 - wire electric cable from the controls in the plant was not long enough. A splice was made using a 3 - wire electric power cable which did not provide a continuous ground back to the control panel. The power cable had been run through an eyebolt on the pump motor and connected to the pump motor leads. At the point where the cable ran through the eyebolt, the outer insulation of the cable had been removed and

the insulation on one of the phases of the power cable had been worn through. The phase wire was in direct contact with the eyebolt.

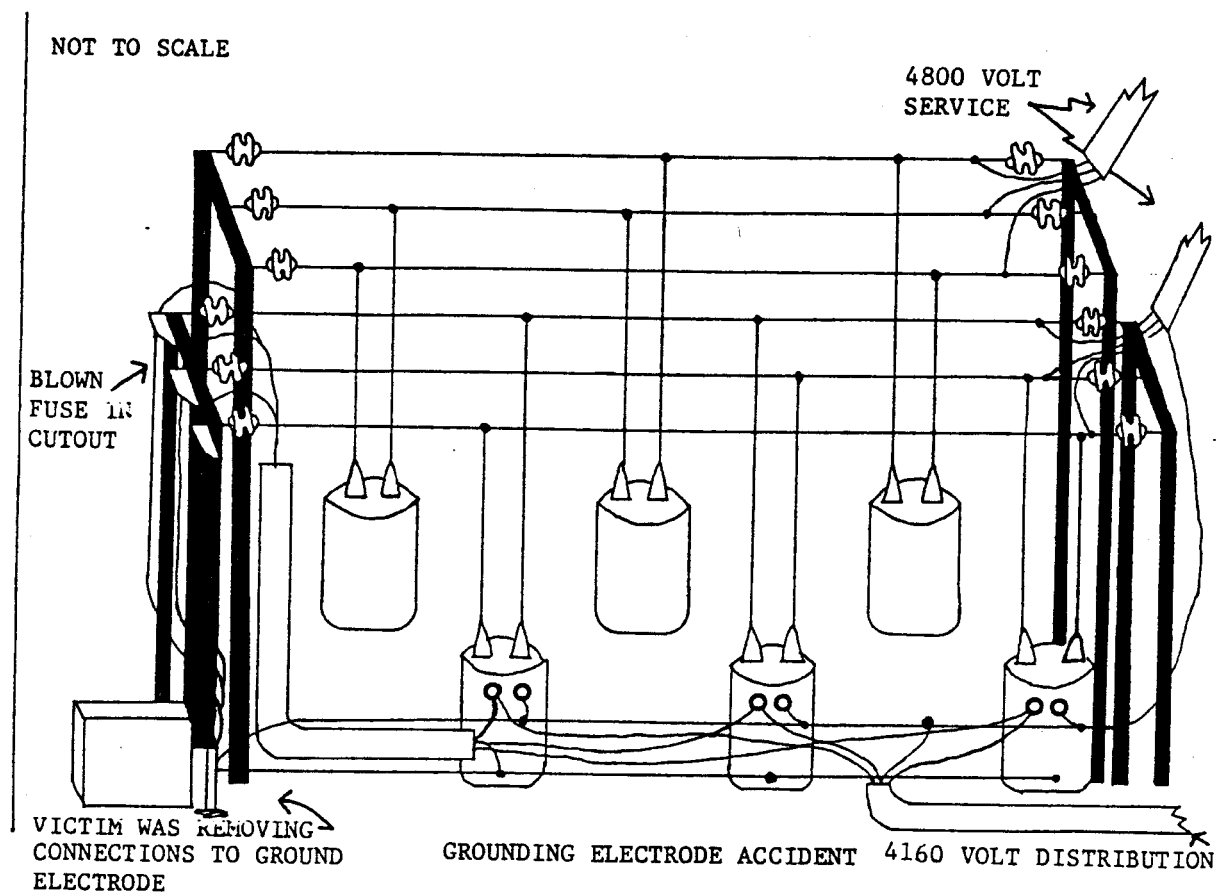
FIGURE 3.

An electrician sustained severe burns to his left forearm when he disconnected the neutral ground from an energized 4160 volt capacitor bank in a substation. The accident is illustrated in figure 3.

Power at the mining operation was reduced from 4800 volts to 4160 volts through two banks of three single phase transformers. Both banks were connected delta-wye with the neutral connected to the system ground. One transformer bank was connected on the 4160 volt wye secondary through fused cutouts to a capacitor bank. The capacitors were connected to the system ground.

The electrician was in the process of isolating the system from all external power sources and power company grounds. He was doing this in order to make a check of the grounding system.

The power was not turned off since it was assumed that the grounding electrode conductor could be removed from the grounding rod on the capacitor bank without any hazard involved. When he removed the grounding conductor from the ground rod an arcing action developed at his arms and hands causing serious burns to both hands and left arm.

The investigation revealed that the voltage potential between the grounding conductor and the ground rod had been 1200 volts. This condition was brought about by a blown fuse in one of the capacitor bank cutouts.
